TODD LAKE DAM

NH 00288

PHASE I INSPECTION REPORT
NATIONAL DAM INSPECTION PROGRAM

AUGUST 1978

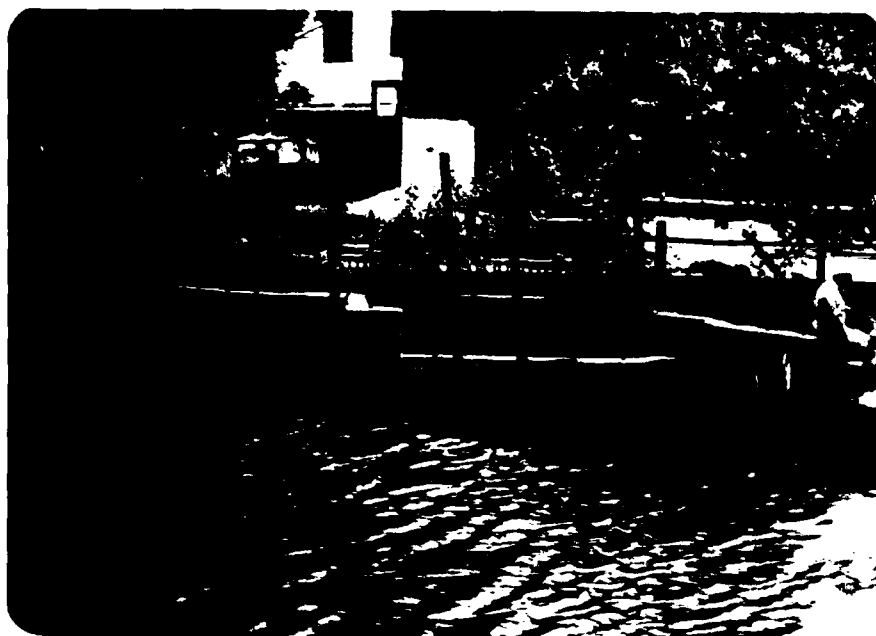
The left abutment, as shown in Photo 3, is of concrete, and overtopping flows would deflect into an open area to the east of the converted mill. A concrete outlet is integral to the left abutment and internal dimensions are approximately 7 feet wide and 11 feet long. The structure is approximately 9 feet deep. The concrete contains medium random cracking and efflorescence. The water level within the structure was approximately 1 foot below lake level on June 1, 1978. The structure has two inlets and one outlet. One inlet is on the upstream face of the structure and the other is in the right wall. The upstream inlet consists of a 4 foot by 4 foot opening. It was not possible to measure the dimensions of the right inlet. Both inlets are sealed with wood. The outlet, which has stop-logs set in place, is on the downstream end of the structure. The top of the stop-logs are 5.3 feet below the top of the structure. Due to their submerged condition, visual inspection of the stop-logs is not possible, however a representative of the owners indicated that they are 4 inches in nominal thickness. There is leakage at the inlet end of the penstock, probably due to faulty seating of the stop-logs. The wood stave penstock is in poor condition and beyond salvage. At least 50 percent of the staves are completely deteriorated (Photo 6).

3. View of outlet structure from right abutment
(1 June 78)

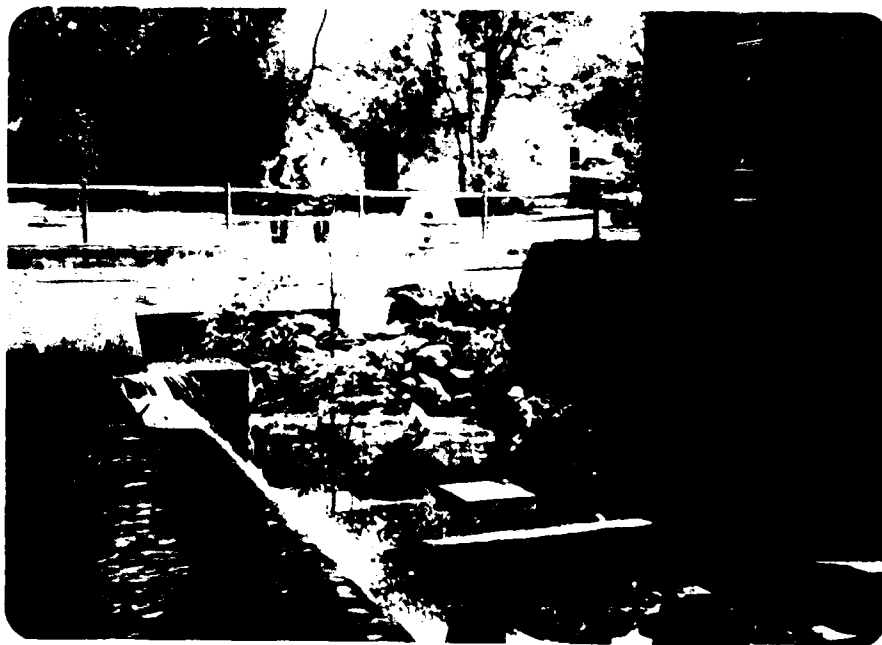
6. View of penstock from right abutment
(1 June 78)

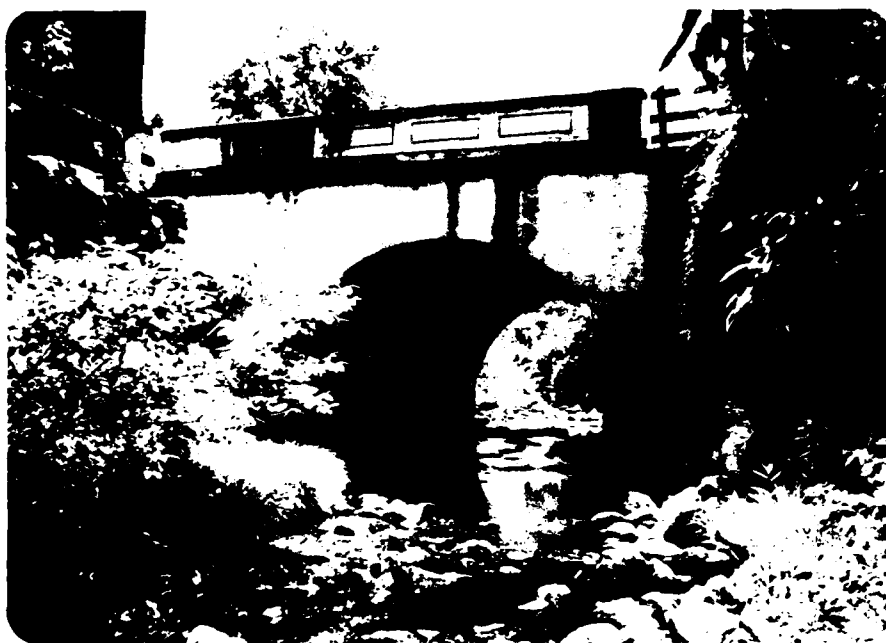
The existence of the road bridge just downstream of the dam would create significant backwaters at the dam in the event of the STF, a situation more beneficial than harmful in terms of the dam's structural stability. The bridge is a concrete arch with a width of approximately 16 feet and a maximum height of approximately 16.5 feet. The narrow, steep channel for some distance downstream virtually assures high water levels around the channel, but the lack of any significant downstream development indicates that property damage is the greatest danger.

7. View looking downstream of road bridge just below dam
